INSPECTION REPORT

REPORT NO.	CLIENT P/O NO.	DATE OF REPORT	TOTAL PAGES
TTI20151126-**	/	26 th Nov. 2015	7

CLIENT	*****	VENDOR	*****
INSPECTOR	Mark	PLACE OF INSPECTION	*****
DATE OF VISIT	26 th Oct. 2015	TYPE OF INSPECTION	1- 20% Pressure test witness 2- 20% Visual check. 3- 20% Dimension check
VALVE TYPE	Gate valve		
ORDER QTY	858PCS

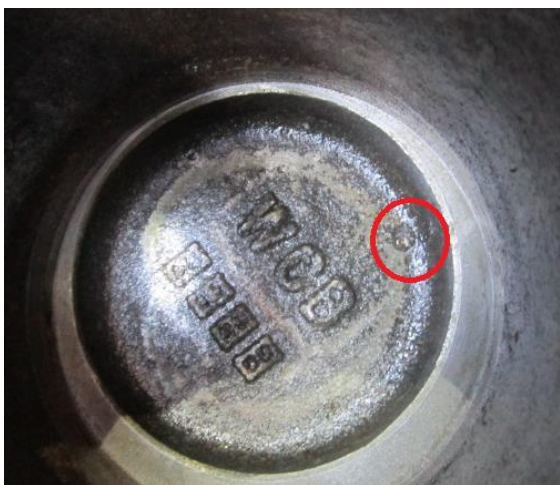
Item12,S/N:15101939, disc casting leakage

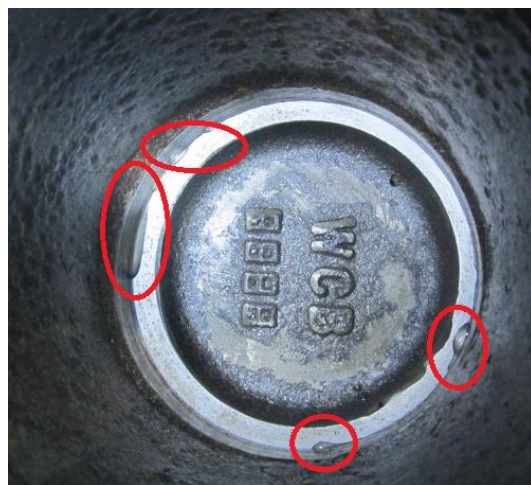
Item12,s/n:15101957,hydraulic seat leakage

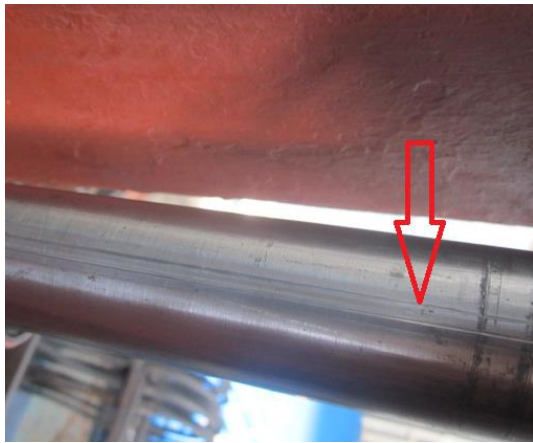
Item16, the stem is damaged

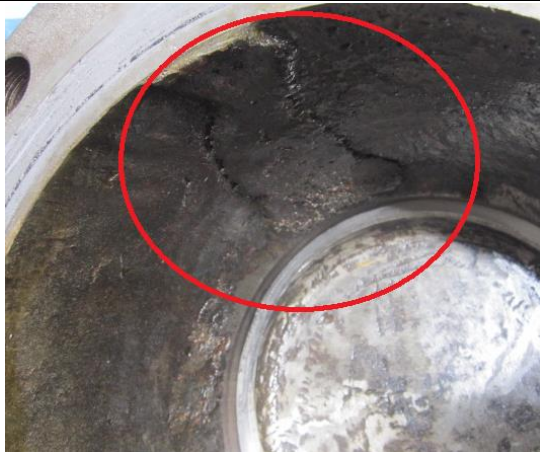
Item 21, the bore has sand inclusion

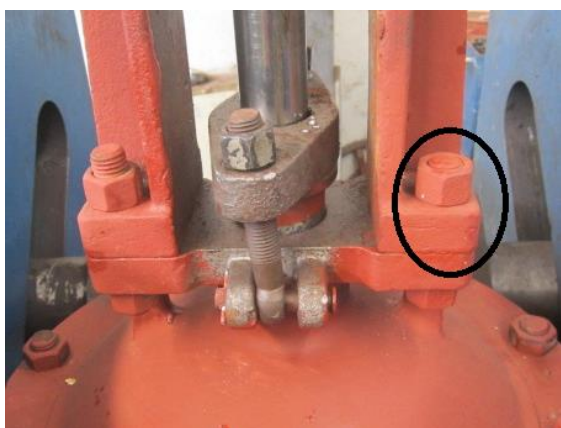
Item 28, 1pcs stud is short

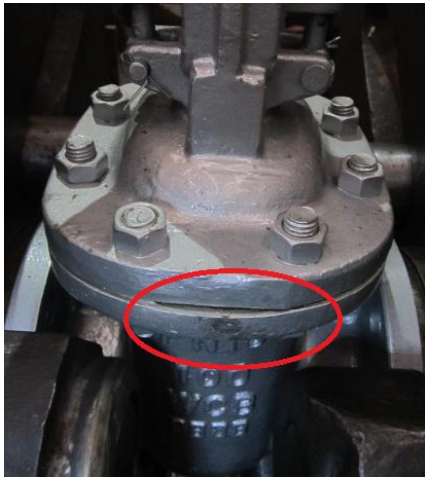
Item12, s/n:15101939, the body and bonnet flange misalign

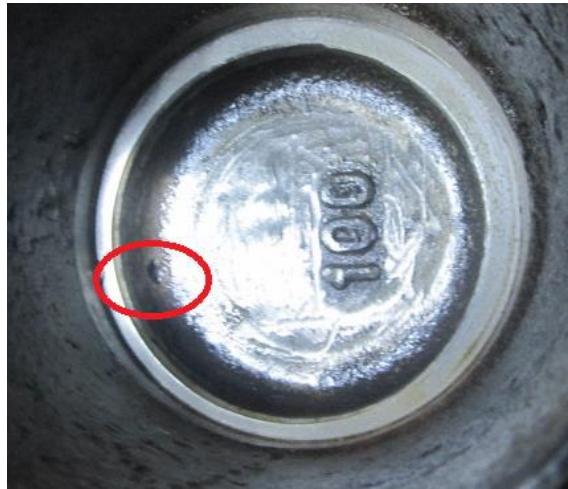
Item12, s/n:15101957, the disc has air hole

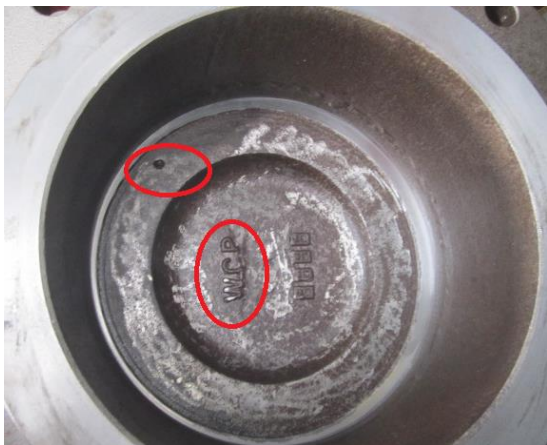
Item16, the bore and disc are rusty, the disc has air hole, the "WCB" marking isn't clear

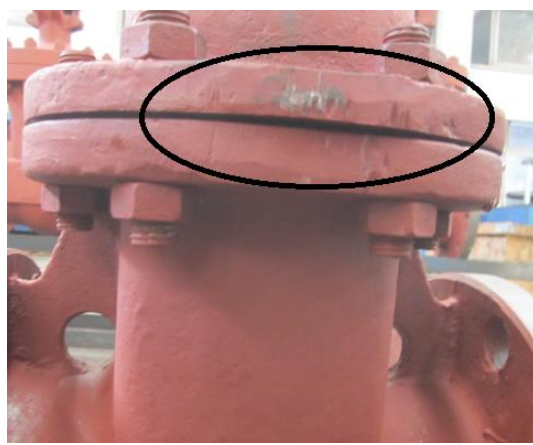
Item17, s/n:15102009, the body and bonnet flange misalign

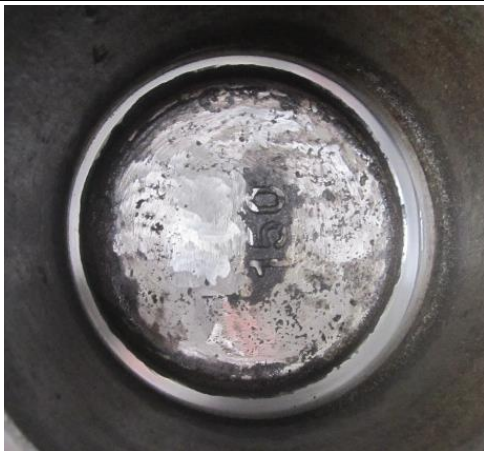
Item17, s/n:15102011/15102022, the disc surface roughness isn't good

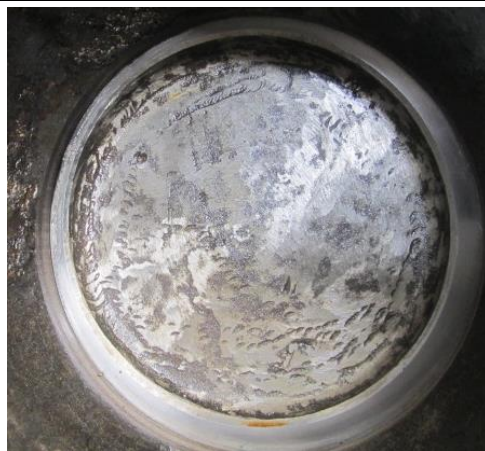
Item21/22, the disc surface roughness isn't good

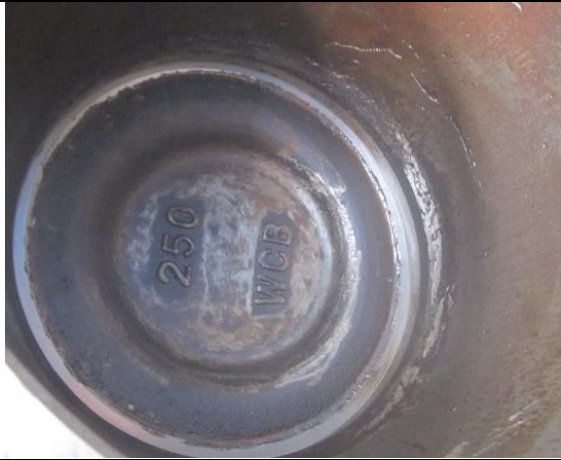
Item28, the bore and disc rusty, bore has defects

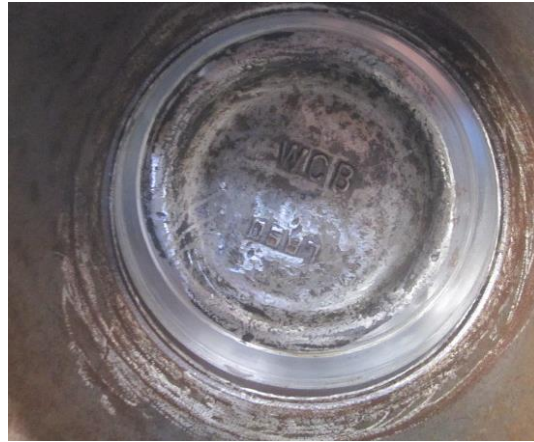
Item30, s/n:15102701, the disc surface roughness isn't good

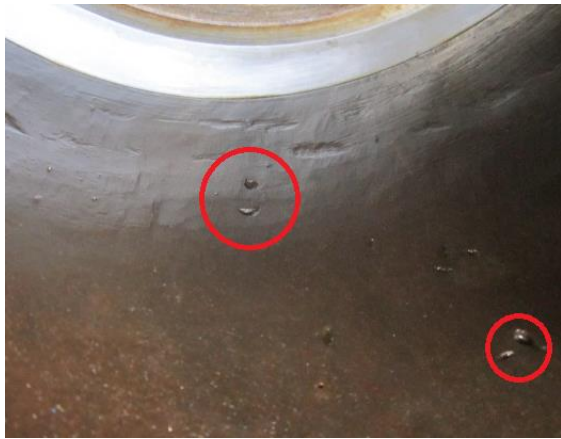
Item48, s/n:15101801, the bore has air holes

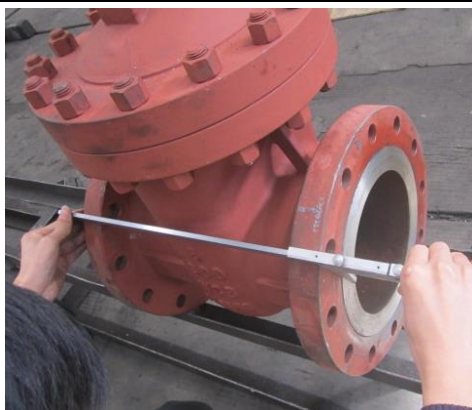
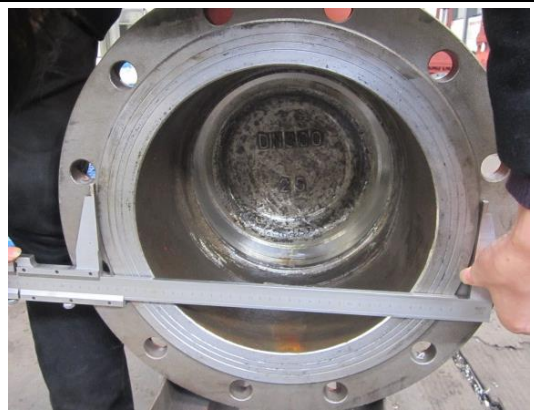
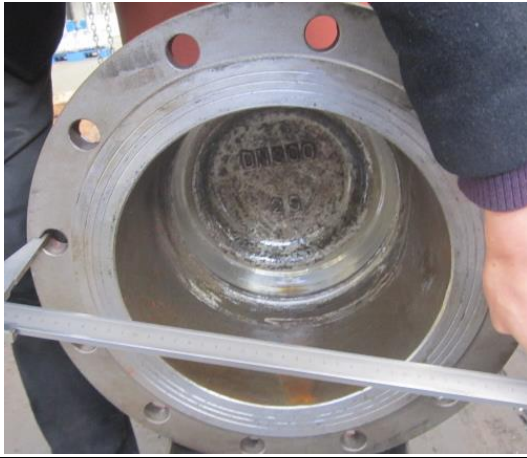
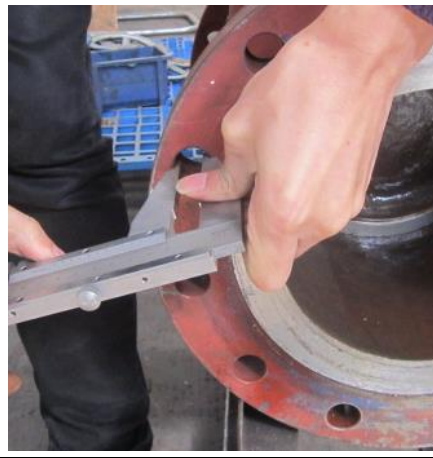
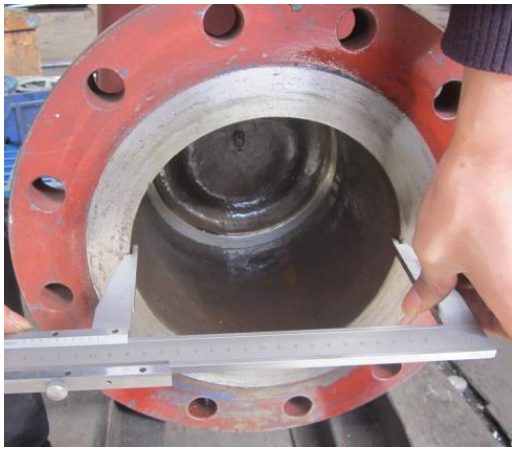
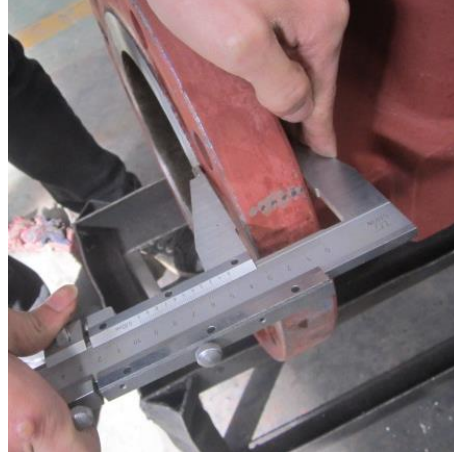
1. item 22, s/n:15102105, the face to face dimension is 325.5mm, which is shorten than drawing dimension $330\pm 3\text{mm}$, factory promised to replace a new body!
