INSPECTION REPORT

REPORT NO.	CLIENT P/O NO.	DATE OF REPORT	TOTAL PAGES
TTI20170724-*****	PO2424-12-15	24 th July. 2017	7

CLIENT	*****	VENDOR	*****
INSPECTOR	Bill	PLACE OF INSPECTION	*****
DATE OF VISIT	22 th ~24 th July. 2017	TYPE OF INSPECTION	1- 10%Visual, 1%Marking and 10%Dimension check.
VALVE TYPE	Flanges		
ORDER QTY	4048PCS

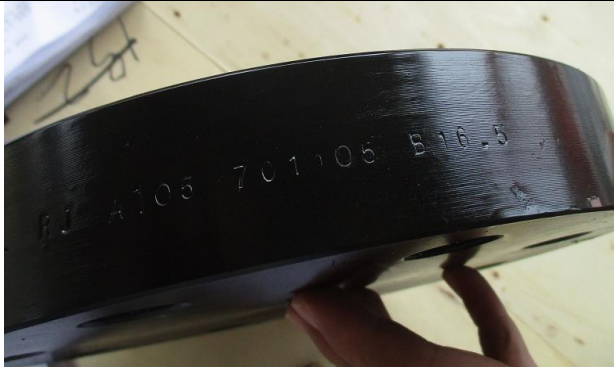
All RTJ end flanges had no ring groove number marking

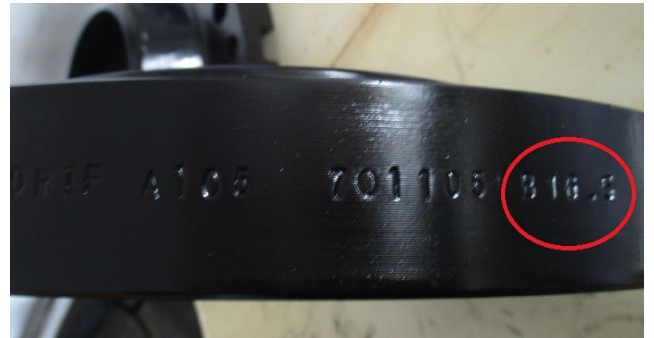
Item96,97, Marking required "B16.36" actual marked "B16.5"

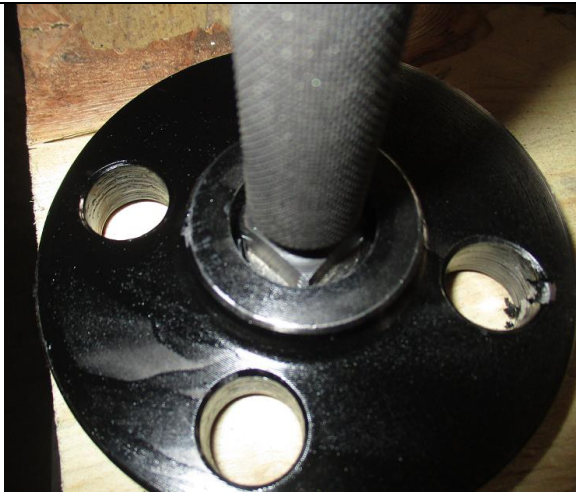
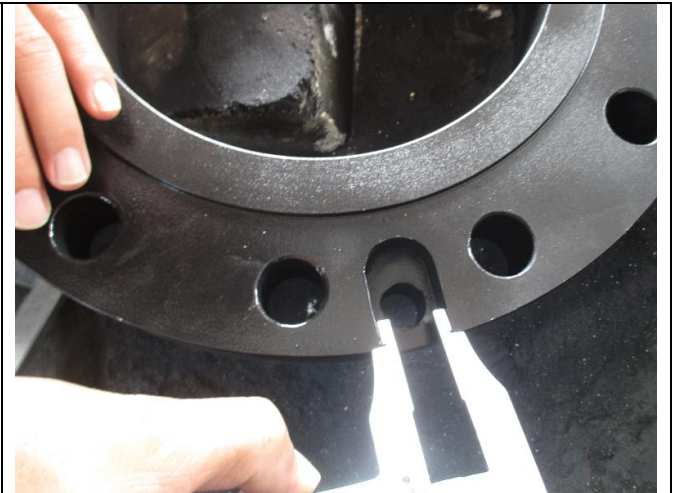
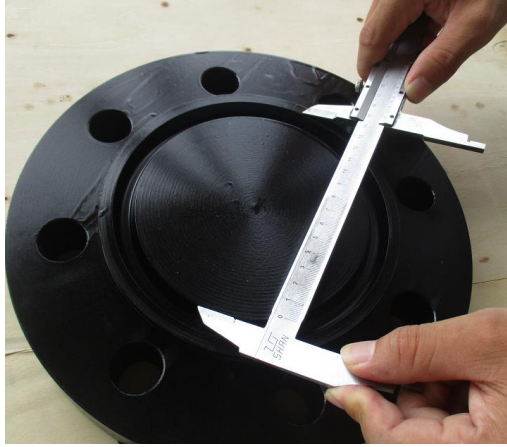
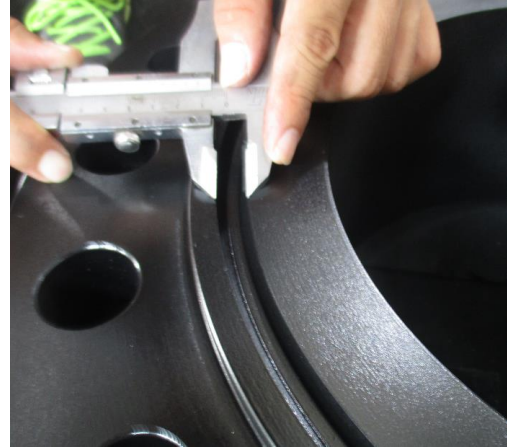
- 1, Item96.97.100.101, 1042,104, the NPT gauge can't pass through
- 2, item97, 1pcs, the NPT hole was too deep, it was scraped;

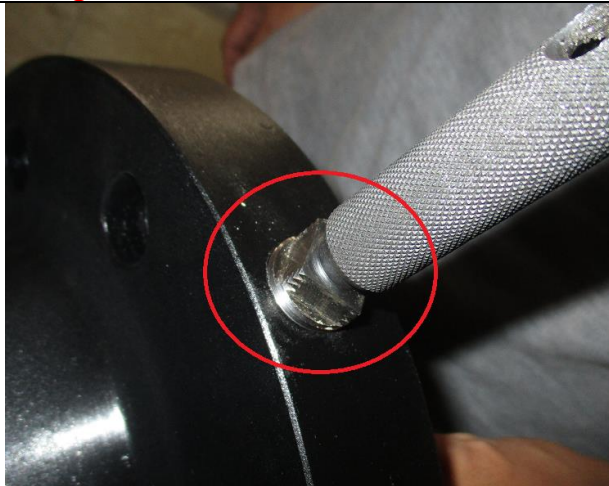
NPT thread can't pass through, factory had finished reworking all NPT thread.

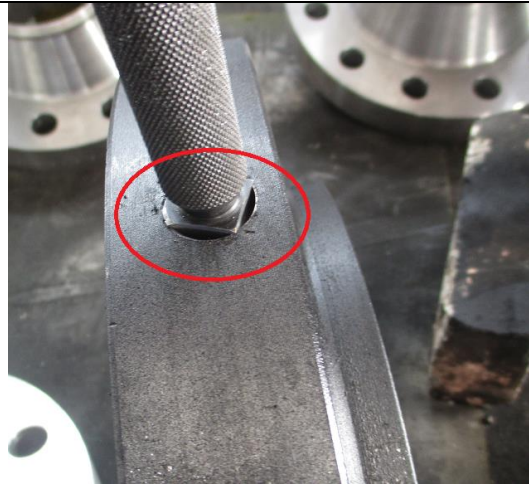
Item97, 1PCS NPT hole is too deep, factory said they scraped it, and replaced a new one

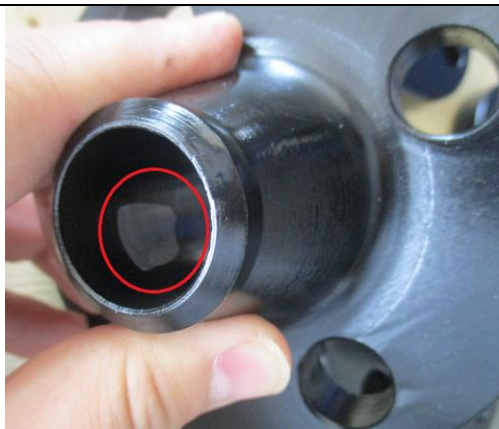
Item56, 1" WNRF 300# S40 ANSI B16.5, Most of them had painting problem in bore surface

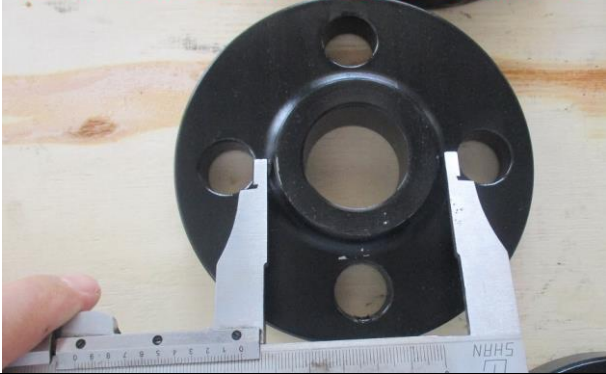
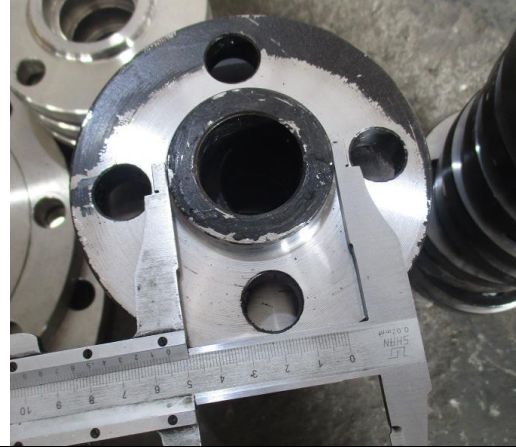
ITEM47, 1"-300LB RF SO Flange, the diameter of Hub was more than standard, which would effect installing of nut.

ITEM 47, 1"-300LB RF SO flanges, the Hub diameter was over standard.

Factory had reworking them

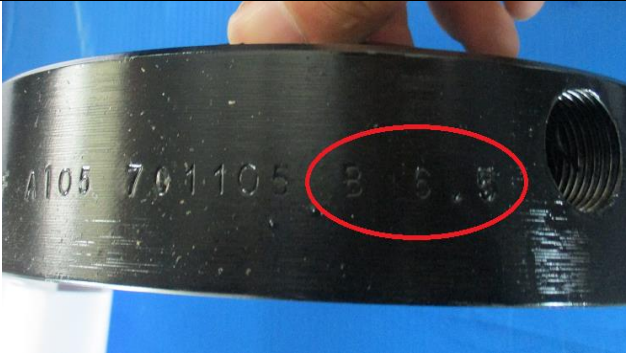
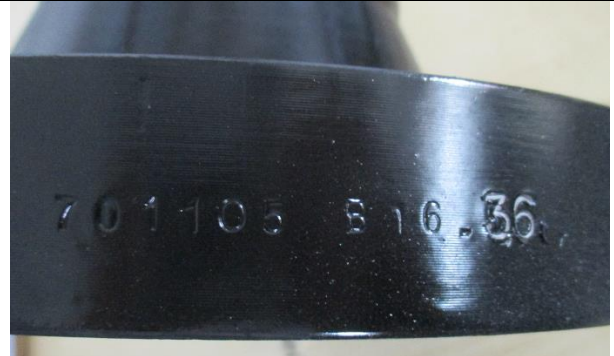
Item95.99, B16.36 flanges marked " B16.5"

Factory had modified the marking

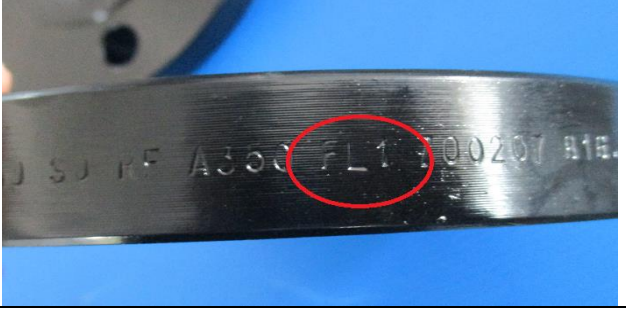
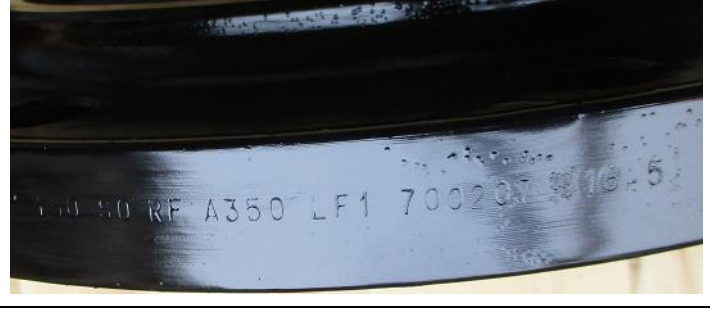
Item 108~113, LF1 material marked" LF1"

Factory had modified the marking

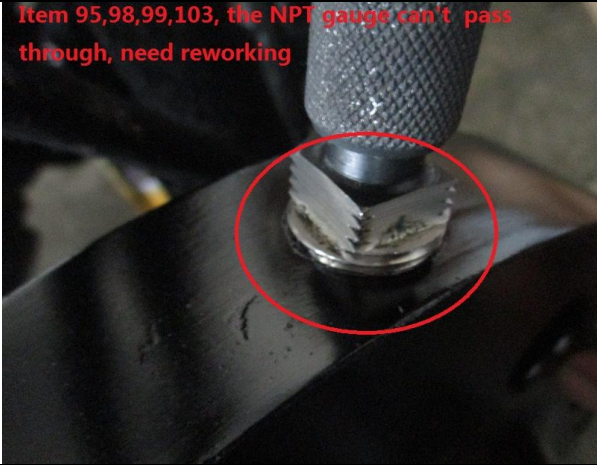
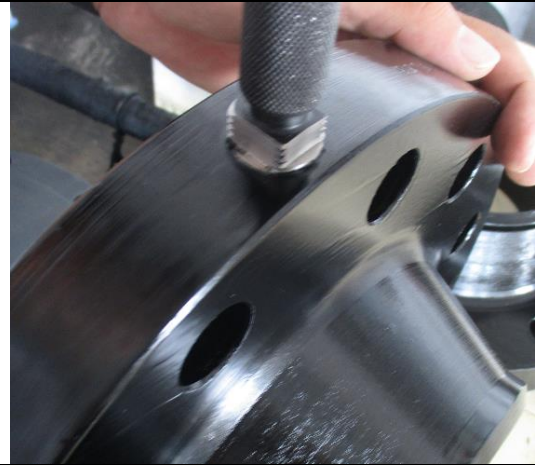
Item 95,98,99,103, the NPT gauge can't pass through, need reworking

Item 85,98,99,103, NPT gauge can't pass through

Factory had finished reworking

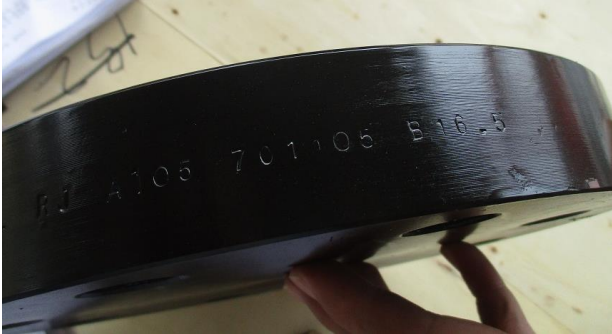
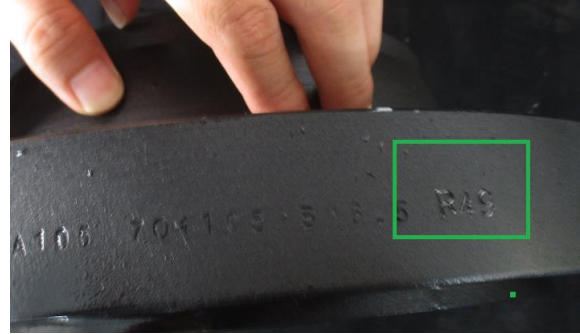
All RTJ end flanges had no ring groove number marking

Factory had add the ring number marking

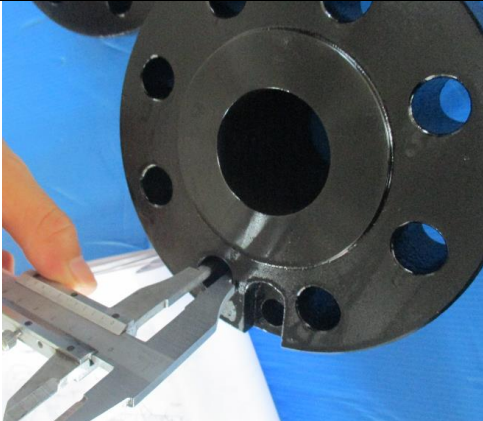
Item103, bolt hole diameter require 19mm, actual dimension is 18mm, which need reworking

Factory said they scraped all total 6pcs flanges and they will finish replacing new ones in one week.

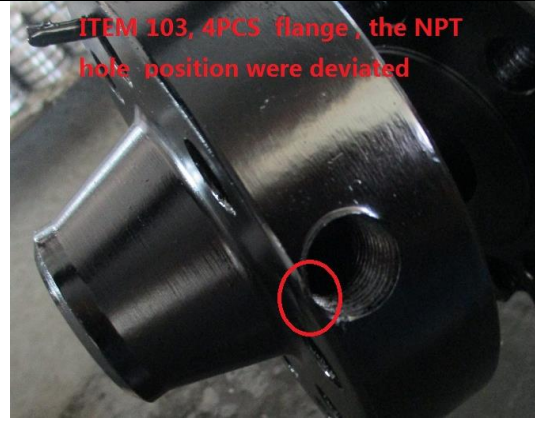
Item103, 4pcs flanges, NPT hole position were deviated
