INSPECTION REPORT

REPORT NO.	CLIENT P/O NO.	DATE OF REPORT	TOTAL PAGES
TTI20150728_****	20150502	28 th July. 2015	8

CLIENT	*****	VENDOR	*****
INSPECTOR	Kevin	INSPECTION DAYS	4days
VALVE TYPE	API-6A Gate valves	QTY	10pcs
TYPE OF INSPECTION	1- Inspection Qty of order; 2- Visual check 3- Dimensional check 4- Pressure test; 5- Drift test; 6- Drift dimensional check; 7- Documents review;

TTI Inspector performed the inspection of 10pcs API-6A gate valve from *****

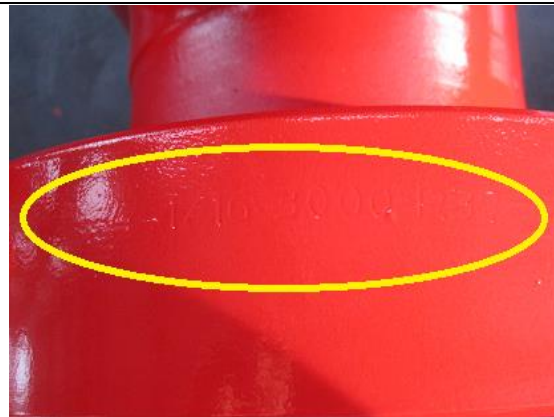
1. All marking is blurry after painting

2. The factory promise to modify the other problems except finding 2.

1. Take off bore rusty
2. All API 6A marking need stamp again, it must be seen clearly after painting.
3. Add "open" and "close" direction marking on hand wheel
4. Rework painting
5. MTR need finish before shipping

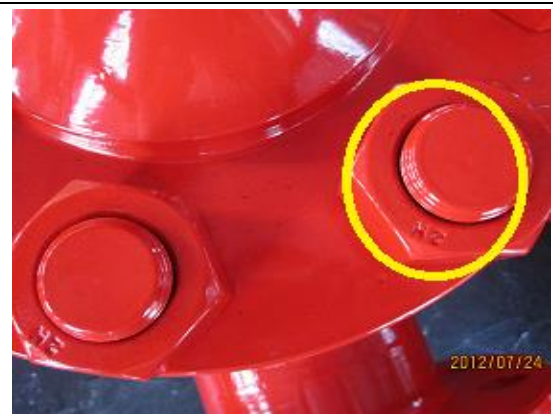
2. All valves stud and nut material is B7/2H, but the drawing is L7M/2HM

Note: 1. Although the stud and nut material is not according drawing, but it comply API 6A DD requirement. Please you comment!

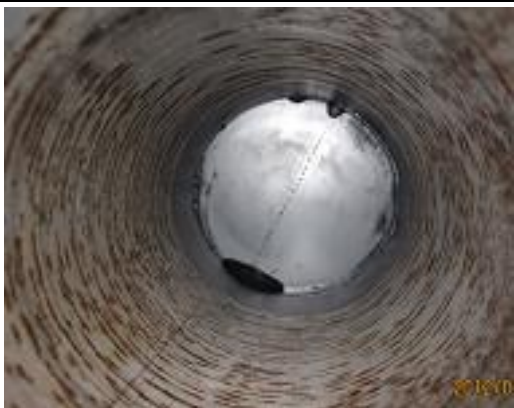
3. The bore of valve is rusty

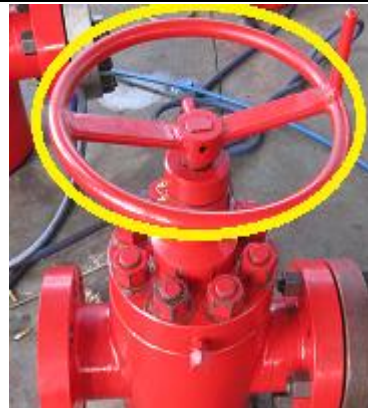
4. All slab valve's hand wheel has no "open" and "close" direction mark

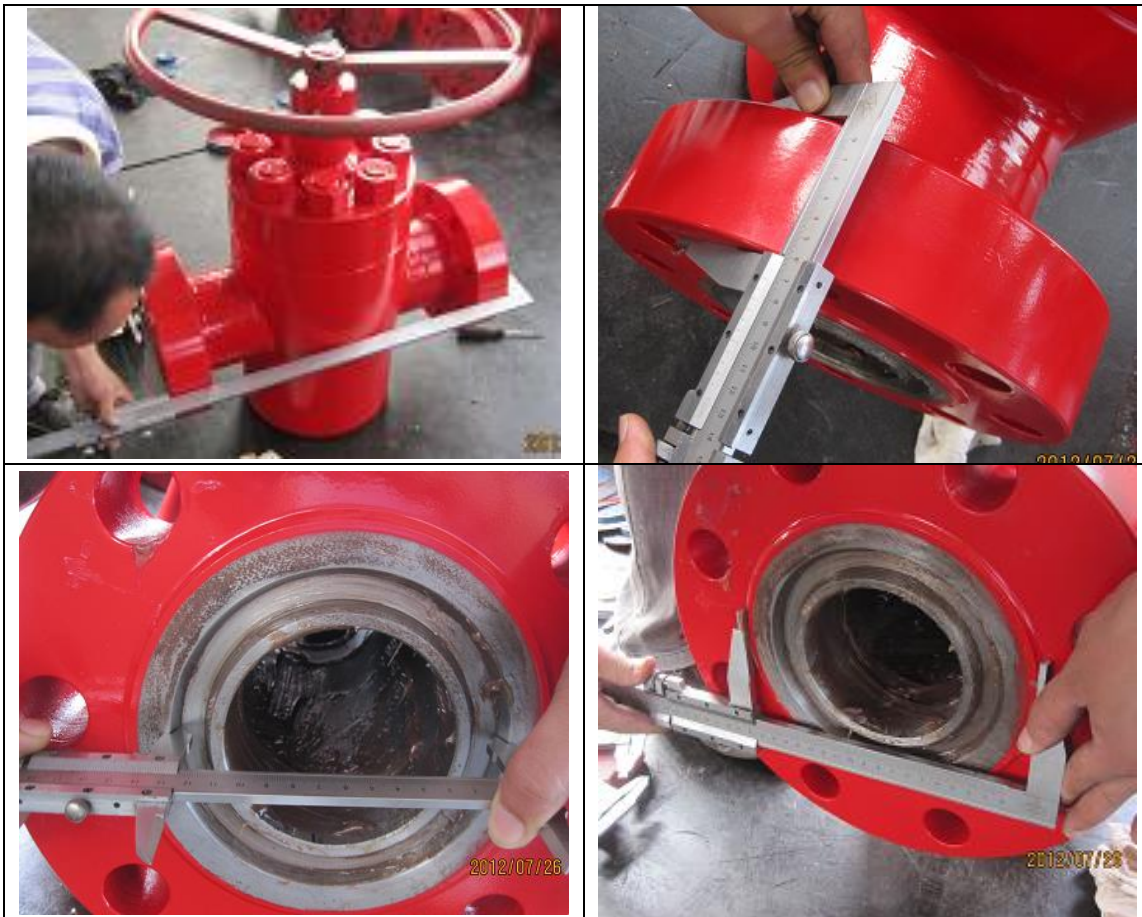
- 1) Please see the attached file "dimensions LIST" for detail!
- 2) Findings: a) 2-1/16" 3000psi expending valve flange thickness is less 0.8mm than std;
 b) 2 -1/16" 10000psi valve, the flange raise face diameter is less 10mm than std;
 c) 2-1/16" 3000psi valve, the face to face dimension is longer 3.5mm than std;
 d) Some valves total height and hand wheel diameter is deviate with drawing.

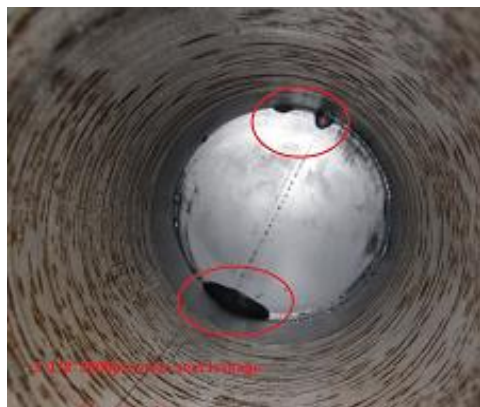
3-1/8"5000psi seat leakage

Note: 1. About seat leakage valves, after lapping wedge and seat again, it passed the testing.

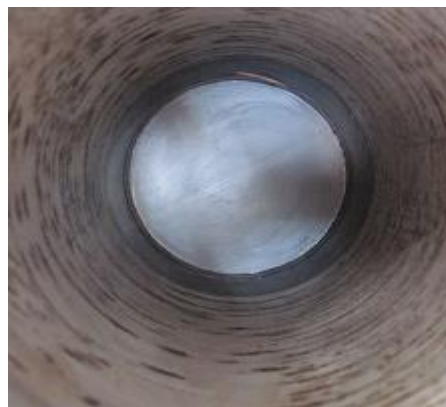
After repair, it is ok!

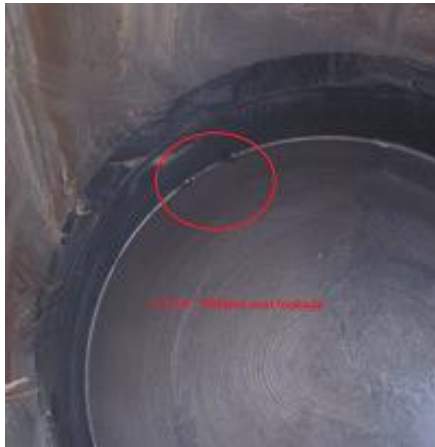
7-1/16"3000psi seat testing leakage

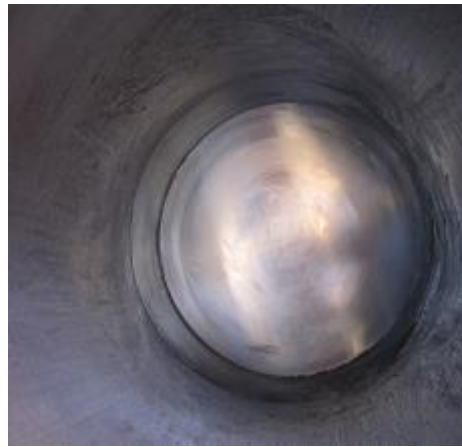
After repair, it is ok!

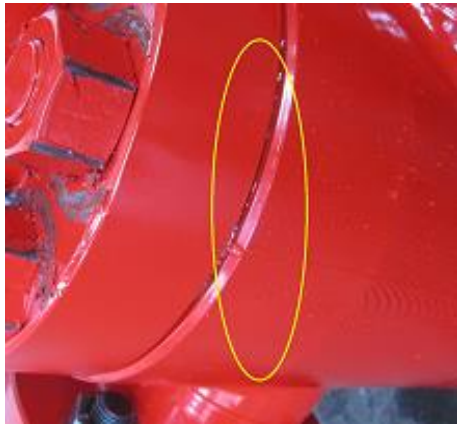
4-1/16"5000psi shell testing leakage

2. About shell leakage valves, after replace a new gasket, it passed the testing.

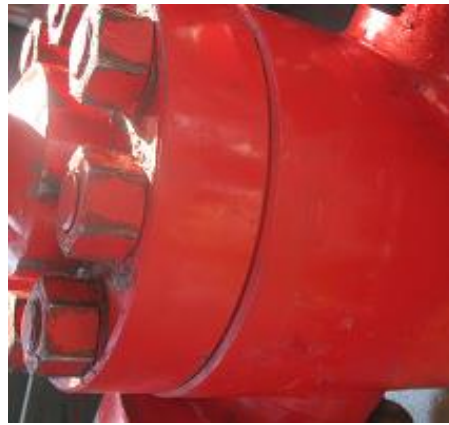
After repair, it is ok!
